## IS YOUR METAL JERRY CAN LID LEAKING? HERE'S HOW TO FIX IT....

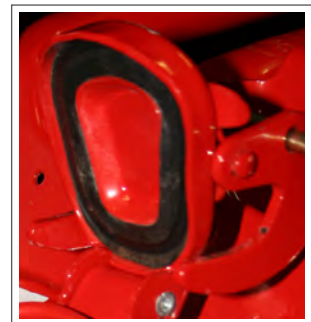
1. First, check if your rubber seal is showing signs of wear or deterioration, or is missing. If so, a replacement should be purchased immediately. These rubber seals should last over three years, even when exposed to fuel, but should be replaced regularly. The rubber seal is vital to ensuring your can will not leak. Check our website for your local retailer or online store.

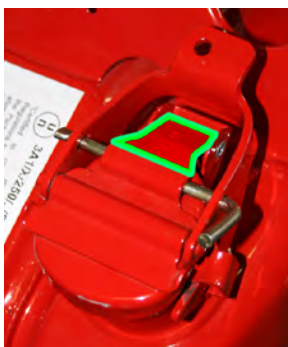
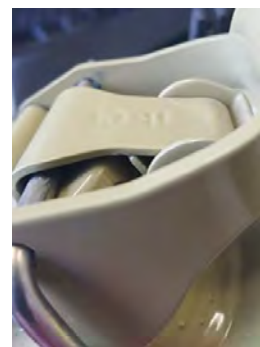
2. If your metal can is leaking from the lid, it has been improperly closed, therefore bending one of the plates. Inspect the date-stamped flat plate connecting the neck to the lid. If the flat plate is in any way bent, the lid will be misaligned and will cause the can to leak.

The Date Stamp Plate should always be flat as shown

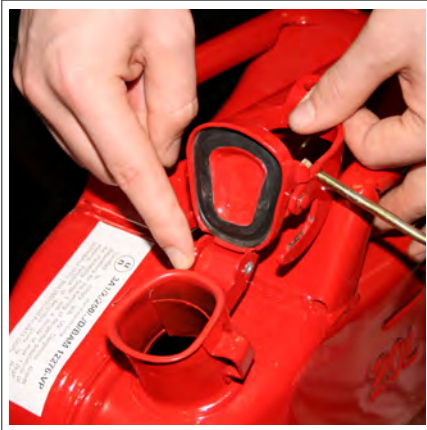
3. To repair a bent lid, open the lid out until it sits in the 'open-locked (down)' position as per image.

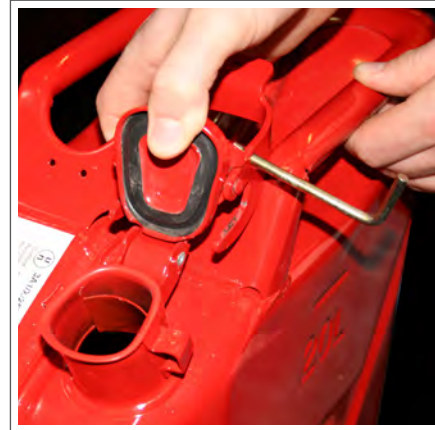
4. Place your thumb on the very front of the lid lip and push towards the back of the can. This should bend the date stamped plate until it is straight again.  
If this does not quite get the plate flat, you can use a piece of plywood to assist.

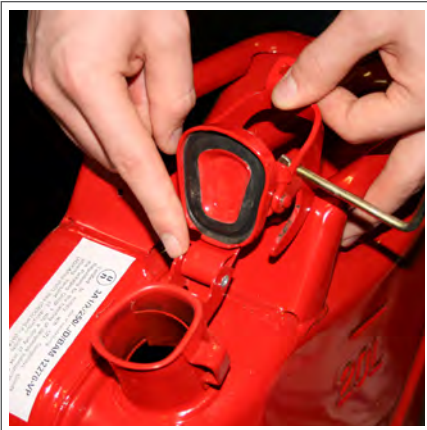
5. Pull the lid up into its 'open-unlocked (up)' position as per image.

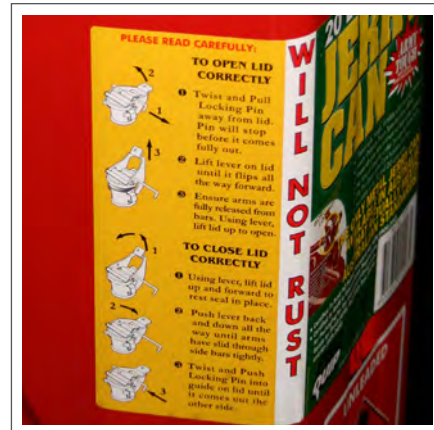
6. Close the lid using the procedures located on the label of the can.
