IS YOUR METAL JERRY CAN LID LEAKING? HERE'S HOW TO FIX IT....

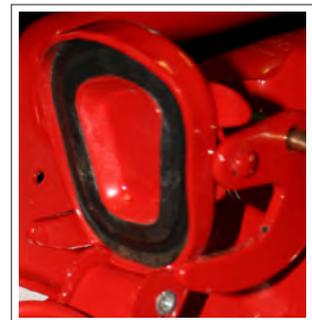
1. First, check if your rubber seal is showing signs of wear or deterioration, or is missing. If so, a replacement should be purchased immediately. These rubber seals should last over three years, even when exposed to fuel, but should be replaced regularly.
The rubber seal is vital to ensuring your can will not leak. Check our website for your local retailer or online store.

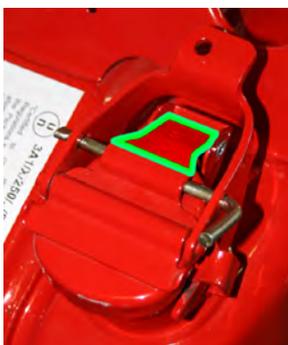
2. If your metal can is leaking from the lid, it has been improperly closed, therefore bending one of the plates. Inspect the date-stamped flat plate connecting the neck to the lid. If the flat plate is in any way bent, the lid will be misaligned and will cause the can to leak.
