IS YOUR METAL JERRY CAN LID LEAKING? HERE'S HOW TO FIX IT....

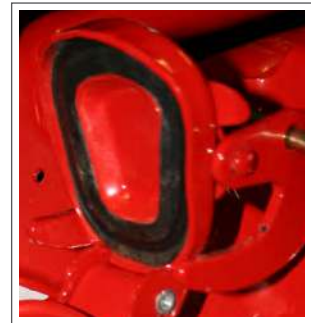
1. First, check if your rubber seal is showing signs of wear or deterioration, or is missing. If so, a replacement should be purchased immediately. These rubber seals should last over three years, even when exposed to fuel, but should be replaced regularly. The rubber seal is vital to ensuring your can will not leak. Check our website for your local retailer or online store.

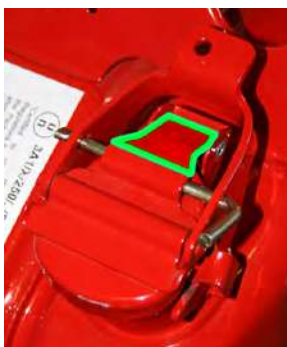
2. If your metal can is leaking from the lid, it has been improperly closed, therefore bending one of the plates. Inspect the date-stamped flat plate connecting the neck to the lid. If the flat plate is in any way bent, the lid will be misaligned and will cause the can to leak.

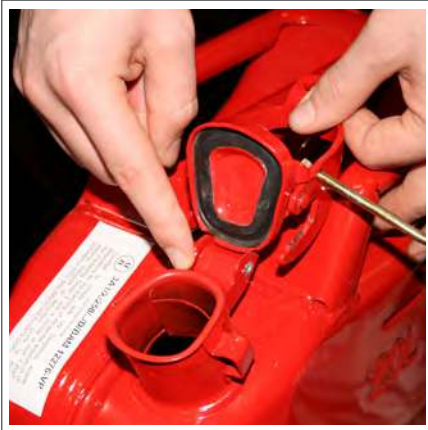
The Date Stamp Plate should always be flat as shown
